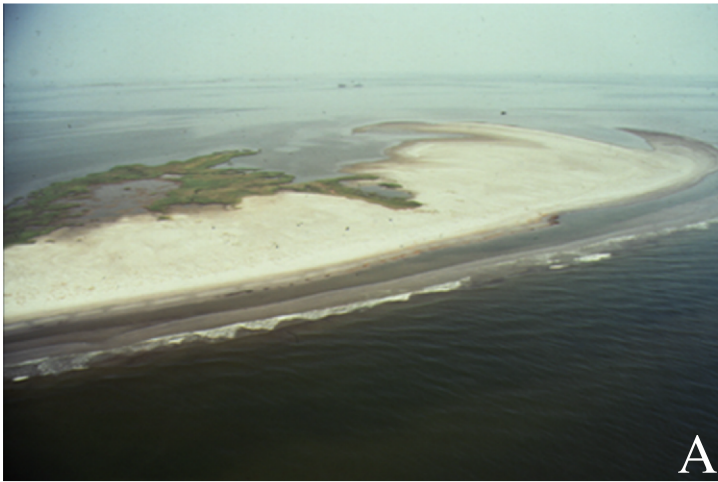
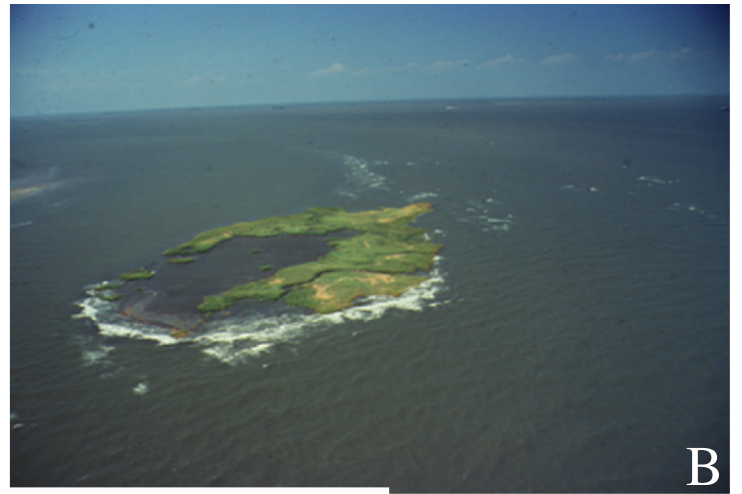
Figure 5. Photographs taken 7 weeks apart of the east end of Timbalier Island illustrating the severe erosion that occurred along the margin of Little Pass Timbalier during Hurricane Andrew: A) Before - taken July 9, 1992, and B) After - taken August 30, 1992.
